# COMPONENTS OF THE ASSESSMENT

Portland Parks and Recreation currently maintains in excess of 200 structures at various locations around the City. Many of these buildings are considered “minor” structures, e.g., restrooms, picnic shelters, storage buildings, etc. These types of buildings are utilized on a limited and primarily seasonal basis. Therefore, a decision was made to make an initial assessment of only the major structures within the parks system.

# Columbia Pool

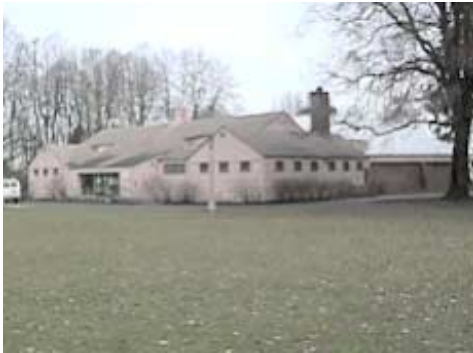
<u>Item</u>	<u>Rating</u>	<u>Comments</u>
Doors	4	
Exterior Paint	1	Paint is peeling.
Exterior Walls	Brick rated 4; wood rated 1	Wood shingles are rotted. Needs replacement now.
Masonry Chimney	3	
Floor	4	
Floor Coverings	2	Showers tile rated 2, changing room vinyl rated 0, family changing area and lobby rated 3. Tile installed over black sealer, each year 5-25 sf areas come loose, tile should be removed, slab cleaned to bare concrete and re-tiled to alleviate problems. Sheet vinyl must be repaired yearly. Loose, wrinkled, seams open with water underneath, getting beyond repair. Replace next shutdown.
Paving / Walkways	4	East side apron rated 2; South side catch basin too low, rated 0.
Retaining Wall	4	
Roof	3	
Windows	2	Poor condition.

<u>Item</u>	<u>Rating</u>	<u>Comments</u>
Controls	5	
HVAC	Overall 5, AHU-1 0, AHU-2 2	Due to corrosion AHU-1 is rated 0, unit will fail soon. AHU-2 is in poor shape and is rated 2.
Plumbing (fixtures)	5	
Water Heater	5

<u>Item</u>	<u>Rating</u>	<u>Comments</u>
Electrical Systems	3	Some electrical beyond life.

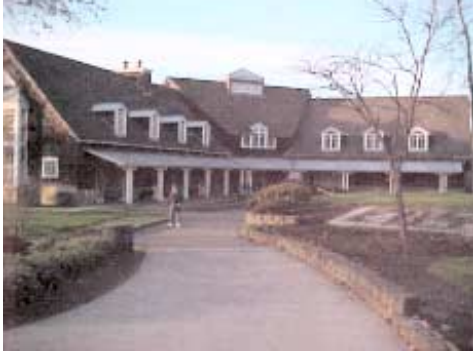
# Eastmoreland Golf Course Clubhouse

<u>Item</u>	<u>Rating</u>	<u>Comments</u>
Doors	3	Kitchen service entry rated 2, metal back doors rated 3, front doors rated 4, all need paint / finish, fronts need weather-strip replaced.
Exterior Paint	1	Needs paint NOW. Serious damage to wood trim has already begun.
Exterior Walls	5	Stucco lower 3', wood shingles upper, good condition except for paint.
Fireplace Chimney	5	S/S flue in wood chase, unable to inspect.
Floor	5	First floor slab on grade, second floor wood frame, concealed, no apparent defects.
Floor Coverings	3	Men's restroom rated 1, carpet on main floor lobby & pro shop rated 2, women's main floor restroom rated 2, rest of building rated 3-4.
Paving / Walkways	4	Front entry & patio rated 3, several cracks, monitor for changes; front steps rated 3, heavy wear, crack in center. Monitor annually.
Retaining Walls	5	
Roof	5	Overall good, although several broken or loose tiles need repair ASAP.

Windows	5	Wood clad, insulated, good condition.

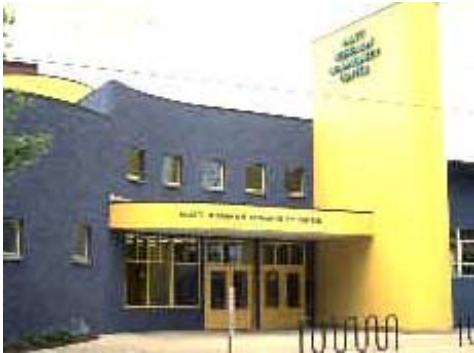
# Matt Dishman Community Center and Pool

<u>Item</u>	<u>Rating</u>	<u>Comments</u>
Doors	Exterior 5, Interior 4	Hardware rusted in pool area.
Exterior Paint	0	Needs repainted.
Exterior Walls	5	
Floor Coverings	Ceramic 4, VC Tile 4, Gym 4, Auditorium 4, Boxing Room 2	Clean and grout ceramic tile next 1-2 yrs.; boxing room floor has water damage at north end.
Paving/Walkways	Parking 2, Sidewalk 5	Blacktop cracked/settling – repave 2-3 yrs. max.; grind raised crack west side of building walkway.
Roof (Hypolon & Torchdown Flat)	5	
Windows	Exterior 1, Interior 5	Exterior windows leak, cranks broken, glazing loose or missing, interior window between pool and lobby rated 1 (frame rusted out).

<u>Item</u>	<u>Rating</u>	<u>Comments</u>
Controls	5	Pneumatic controls rated 2.
Elevators	5	
HVAC	5	AHU-2 rated 2.
Plumbing (fixtures)	5	
Water Heater	5

<u>Item</u>	<u>Rating</u>	<u>Comments</u>
Electrical Systems	3	Electrical panels in 1992 pool addition, although in good condition, are obsolete. Electrical panels throughout the community center are 10 years beyond service life and need to be replaced.
Fire Alarms	5

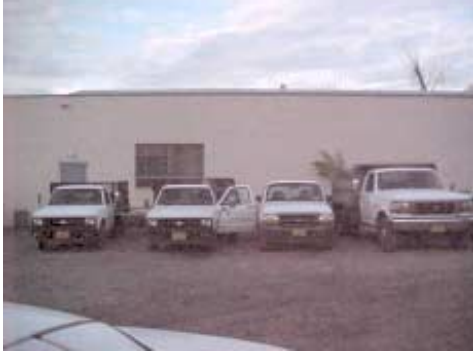
# Northeast District Headquarters

<u>Item</u>	<u>Rating</u>	<u>Comments</u>
Doors	2	Five doors rated 2 including basement garage door; main level garage door rated 3.
Exterior Paint	2	
Exterior Walls	4	Some minor cracking in concrete wall.
Floor	4	Main floor structural concrete, basement is slab on grade, with many stress cracks but no settling.
Floor Coverings	4	
Paving/Walkways	Parking 2, Sidewalk 5	Concrete sidewalks rated 4 except 112 sf section in front of drop box needs replaced with apron within 2 yrs.
Retaining Wall	4	
Roof	4	
Windows	2	Metal frame, single glaze, cracked glass, poor condition.

<u>Item</u>	<u>Rating</u>	<u>Comments</u>
Electrical Systems	2	Main service is well beyond life.
